**BRABUS®**

***According to the fact that a Mercedes-Benz Star Diagnosis system is required during installation the installation can be performed only by a certified Mercedes-Benz workshop!***

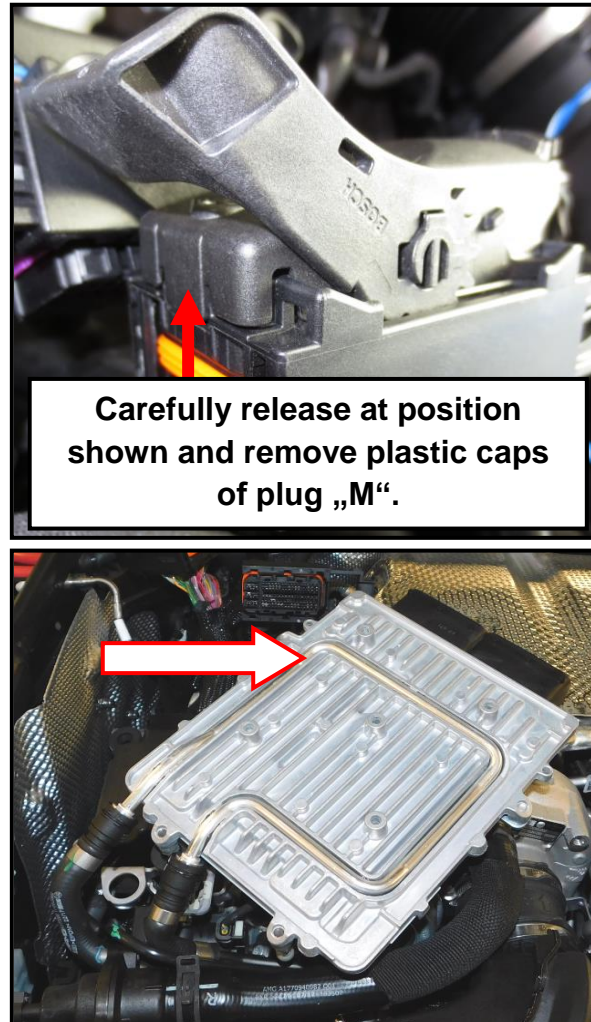
- Release and remove standard wires marked of plug „M“ (slots 40, 33, 55, 32) one after the other using unlocking tool supplied and attach to 4-pole plug supplied (according to illustration).

**Do not release all 4 wires at once as each two wires are of the same color coding - risk of interchanging!  
Make sure not to damage/ deform the pins when unlocking!**

**Unlock the following wires of plug „M“:**

- Left pressure sensor behind throttle valve (B28/22), BN/GY, slot 40
- Left pressure sensor in front of throttle valve (B28/20), BN/GY, slot 33
- Right pressure sensor behind throttle valve (B28/23), BN/OG, slot 55
- Right pressure sensor in front of throttle valve (B28/21), BN/OG, slot 32

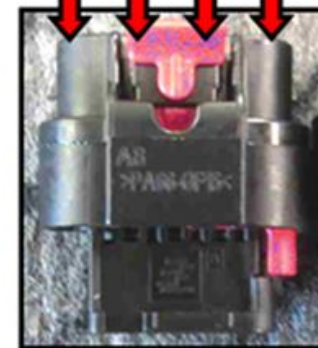
**Attach the wires to 4-pole plug as follows,  
make sure for proper latching!**

- Wire out of slot 40 (BN/GY) to slot 1
- Wire out of slot 33 (BN/GY) to slot 2
- Wire out of slot 55 (BN/OG) to slot 3
- Wire out of slot 32 (BN/OG) to slot 4

**Connect 4-pole plug to 4-pole socket of Brabus wiring harness.**

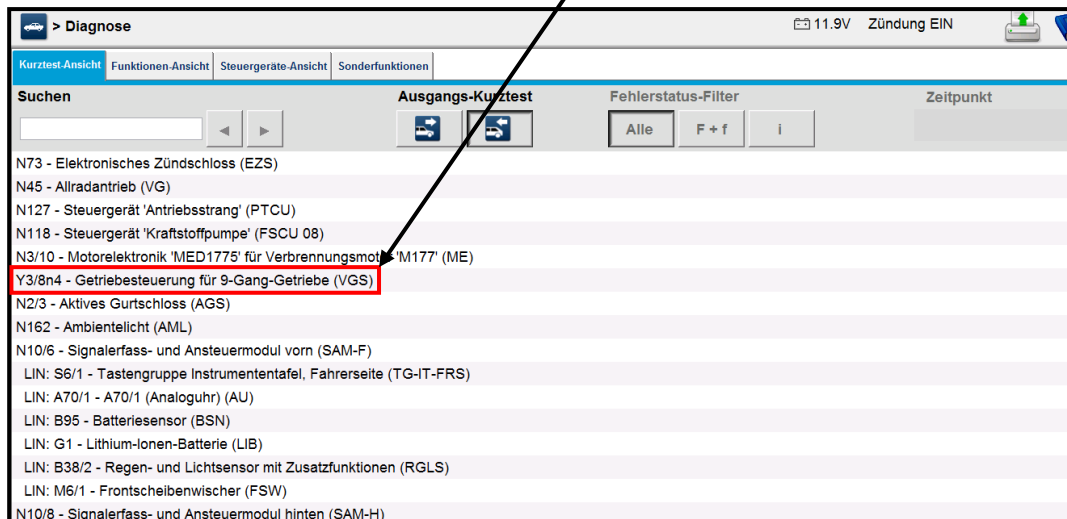
**Connection of CAN-connections within passenger footwell using Star Diagnosis:**

- Switch on ignition
- Connect Star Diagnosis to OBD - port and establish communication
- Choose „Y3/8n4 transmission control unit für 9G-tronic (VGS)“ and visualize actual values

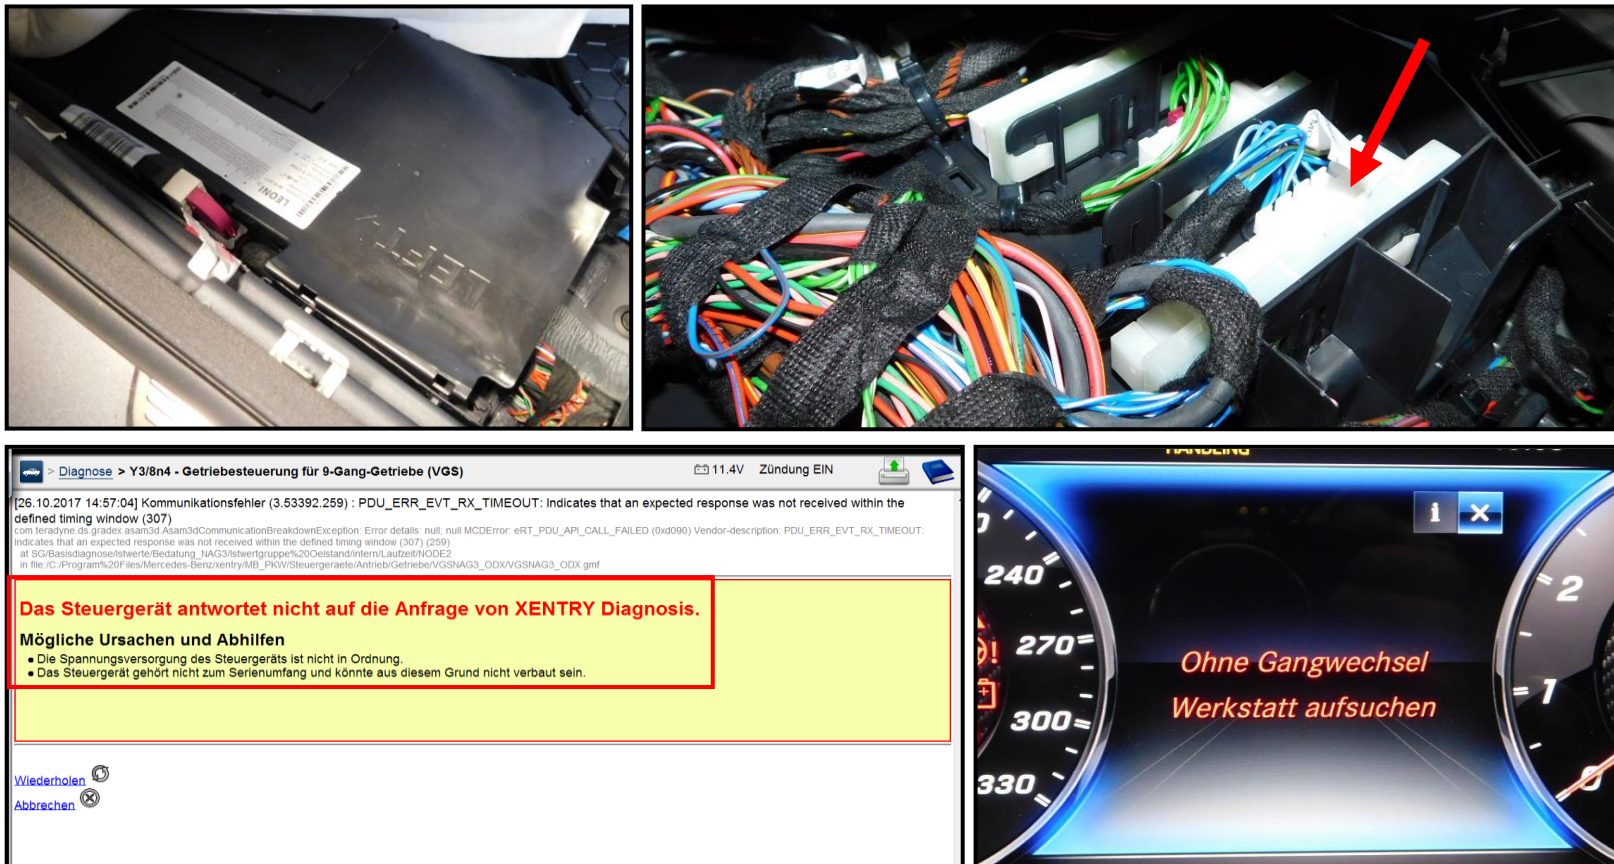
- **Route the CAN-wires into the driver footwell (below dashboard). Disconnect CAN-plugs of CAN-distributor within the driver footwell shown (within cable duct, white plug, wire colors BU/ BU - WS) one after another until a communication fault is shown by Star Diagnosis (and instrument cluster fault message „Without gear change - visit workshop“). The CAN-plug that has caused the fault is to be used and to be connected to the Brabus wiring harness. Attach the remaining standard plugs back into their slots.**

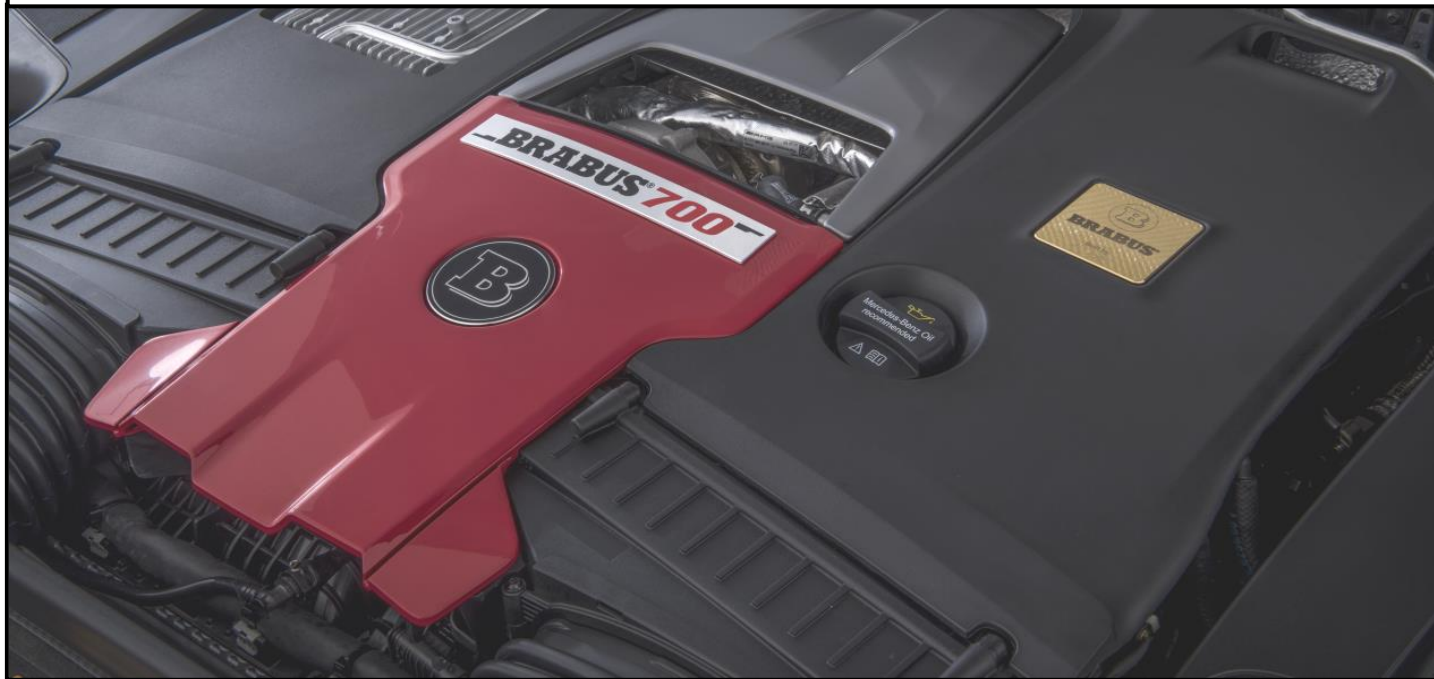
- **Remove standard AMG badge. Clean and carefully degrease the bonding surface of the AMG badge and glue the Brabus badges to the engine plastic cover according to image below. After alignment fixate the badges until the adhesive has hardened.**

**Painting proposal of engine cover: Mercedes-Benz Signal red, color code 568**
